# CONSTRUCTION OF UNDERGROUND SCALE PIT AT ESSAR STEEL – HAZIRA :- DEWATERING AND CONSEQUENCES

**ABSTRACT:** Essar Steel Hazira Ltd has proposed new integrated steel plant near Hazira under SEZ developments. During the construction of 25m deep underground scale pit, there are various geotechnical problems occurred due to dewatering operations. Dewatering followed by soil movements cause settlements of nearby structures including piled raft, chimney etc. This paper describes the entire study from origination to the solution of the settlement problems. Due to these consequences commissioning of entire area had been stopped as settlements have been observed on almost all the adjacent structures. Settlement was continuously monitored on important piled raft and some adjacent structures during entire operation. Paper also describes the methodology adopted for arresting the settlements and some design changes has been made for bottom plug for scale pit.

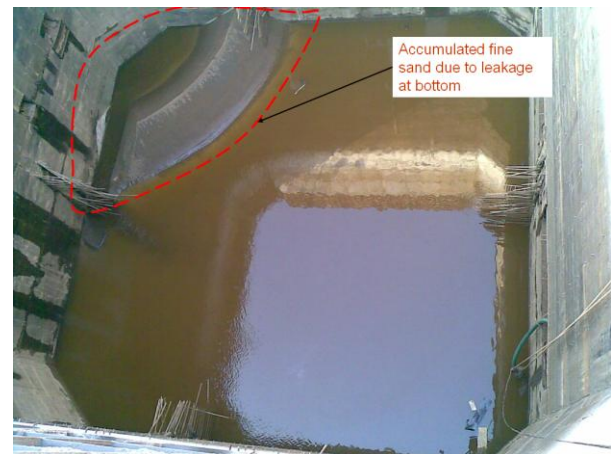
Figure 2 Scale pit view with fine sand at bottom.

When water table is lowered and scale pit bottom becomes visible, it was found that huge qty of fine sand has entered inside left hand side pit compartment (Figure 2). This may be attributed to the earlier attempt of dewatering from inside scale pit after underwater concreting. Strong sand boiling was observed at that location along with some other areas in the scale pit when pumping system suddenly stopped due to sudden power failure. The settlement may be the consequence due to these large soil movement and huge dewatering under tremendous pore pressure generated by differential hydraulic head.

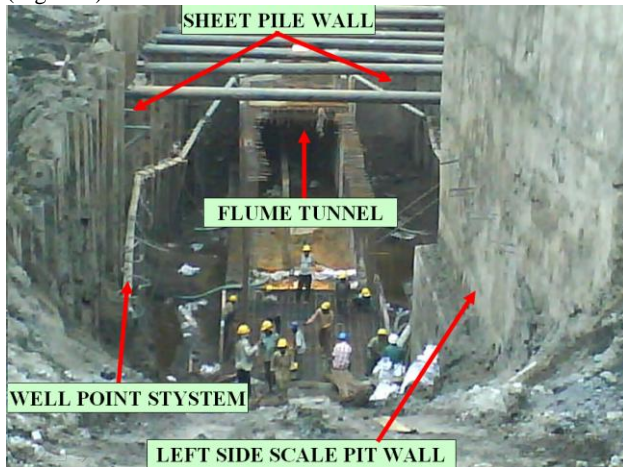
Figure 3. Flume Tunnel with Sheet pile support.

Dewatering from inside the well using extra two pumps and through installed wells were continued till the completion of construction of base raft along with the bottom beams. Pumping was stopped stage wise as it was need to construct the Flume Tunnel on the left hand side of the Scale Pit. As the Flume tunnel has to connect the scale pit at -14m from the ground level, the retaining of the soil around flume tunnel cases big problem. The soil movement around Flume tunnel due to deep excavation may affect the pumping wells, Sheet pile walls are installed to retain the sides of the excavation near left hand side of scale pit (Figure 3).

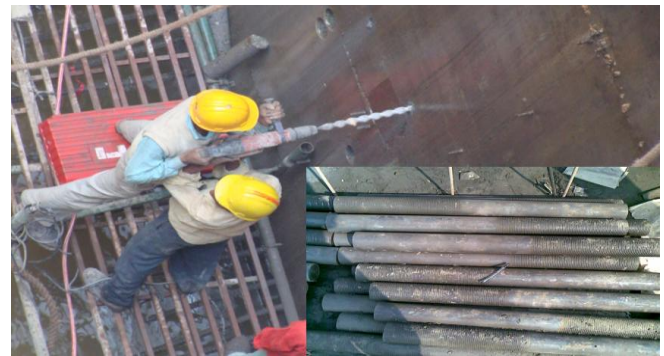
Due to abrupt grabbing and sinking of well at the end of well-sinking operation, entire well has sunk 1m more than the specified level. Therefore it was required to fix new reinforcing bars at specified level to correctly anchor the base raft with scale pit side walls. It was decided to grout 90mm dia rods at 1.2m c/c by drilling in the sidewalls of the scale pit (Figure 4).

Figure 4. Drilling for Extra reinforcement along with anchor rods

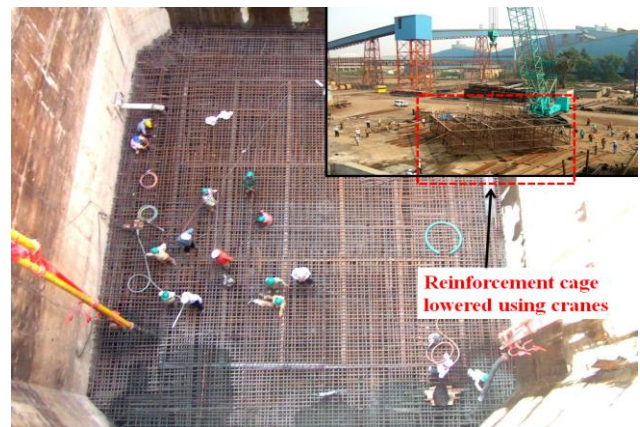
Figure 5. Reinforcements lowered for compartment 1

The raft bottom slab was redesigned and constructed as per new situations. 3m thick raft was constructed in the Scale Pit in three stage as per the Figure 1. The total 1800 m<sup>3</sup> of M-30 concrete was carried out without interruption with installed batching plant. It was very difficult to place reinforcement and bind at -22m hence the reinforcement template was built on ground and lowered using cranes (Figure 5).

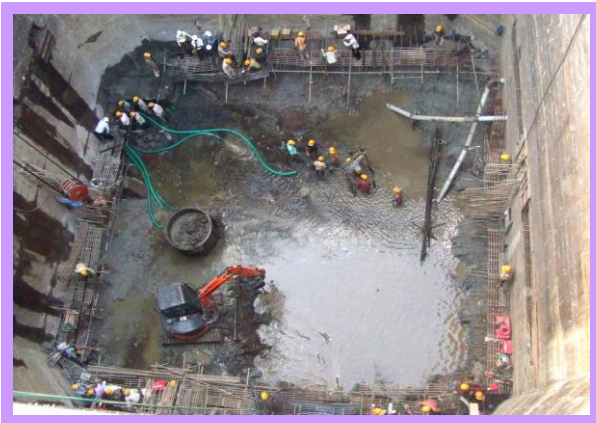
Figure 6 shows the at the condition of the bottom ground after dewatering operations. Even with 9 pumps and some extra pumping from inside, the ground water table cannot lowered more than -20m from the GL. After completion of raft, beams are cast on as per the revised design drawings (Figure 7).

Figure 6. view after dewatering operation.

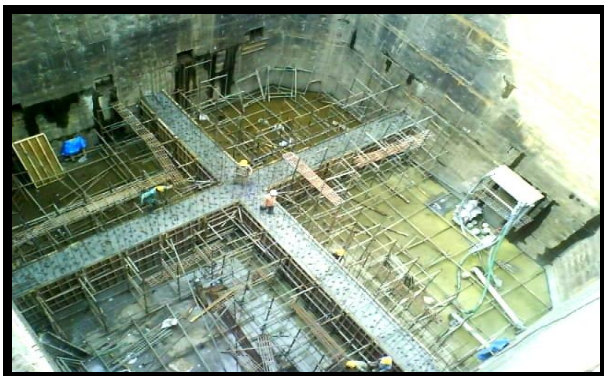
Figure 7. Finished bottom raft with beams.
