LSIT AND HSDPT TO IDENTIFY PILE FOUNDATION FAILURE - CASE STUDY

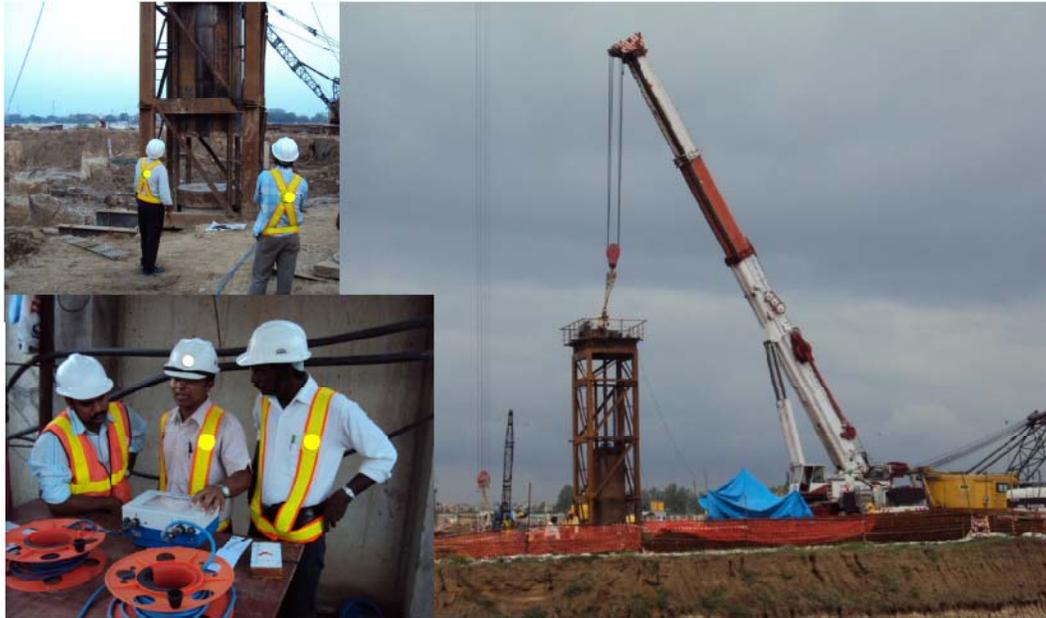
Figure 3 HSDPT in progress using 35ton hammer

The design loads on the piles were estimated to be more than 1200tons implying an ultimate test load more than 3000 tons. As it was a fast track project, it was planned to continue construction activity without any testing. However, as recommended by us and the consultants, nominal testing was planned. Since it was top down construction, it was possible to test from top as a part of the piles was to be used as columns after excavation. Initially LSIT was done on some piles. GD team reported defects in some piles. A typical graph is presented as Figure 2. Other than those piles for tested for PIT, it was also decided to conduct HSDPT on select piles to confirm pile capacity and integrity. HSDPT was performed on selected piles for load carrying capacity assessment. Four pairs of strain gages and accelerometers were attached to the pile head at 90°. A 35 ton hammer, largest used in the country till date was used for the testing. A picture showing HSDPT in progress is presented as Figure 3.
