A Review Low Strain Integrity Testing Practices in India and Complexities involved in Evaluation of Test Results

Keywords: Low Strain Integrity Testing, PIT, Pile Foundation, Deep Foundation

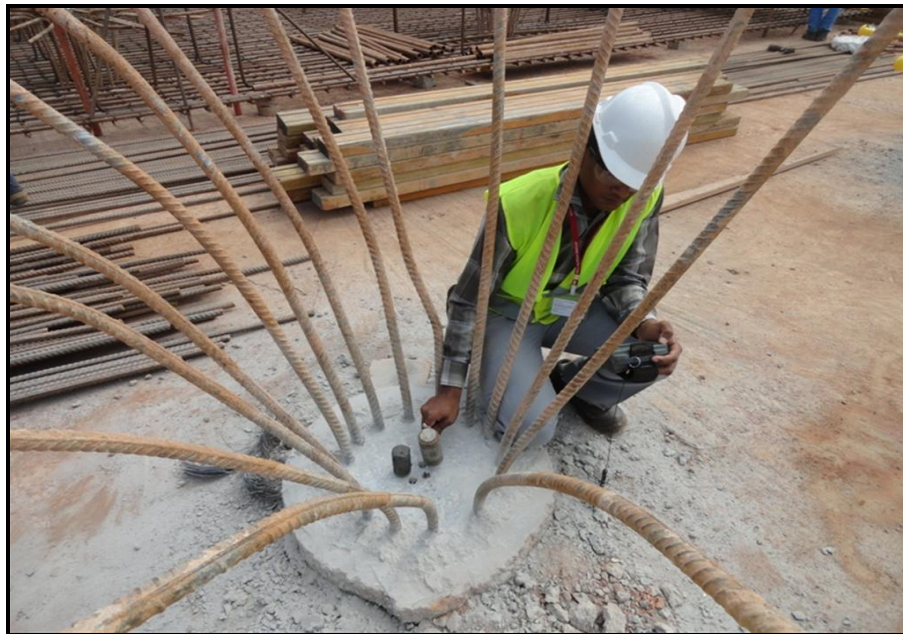
Figure 2 LSIT Data Collection in Progress

Figure 2 shows data collection of Low Strain Integrity Testing on reinforced concrete bored cast in situ pile. The hammer should preferably be close to the accelerometer sensor although the ASTM D5882 allows a distance upto 300mm between the sensor and the hammer. Thus proper position of the hammer,

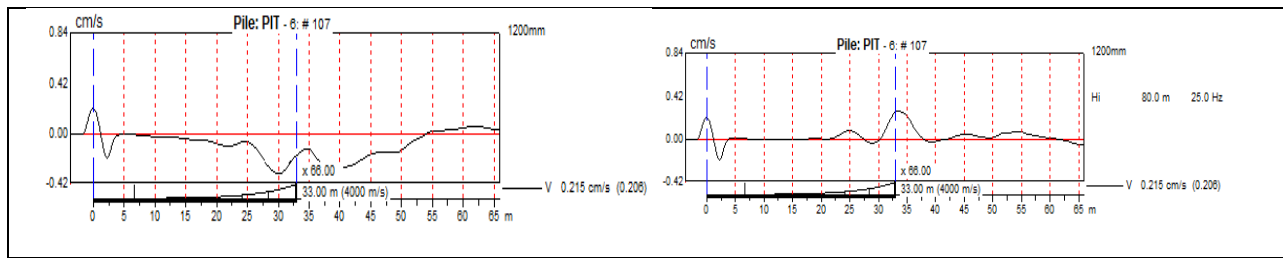
Figure 8 LSIT Graphs without and with HI Pass Filter (HI = 80)

Figure 8 represents such a case study with zero value of HI Pass filter and a corrected response with a value of HI = 80 which is more than 20 times the pulse width. Once a proper value is input, the pile shows clear defect which otherwise was not evident with an incorrect or “zero” value. The HI can be any value of zero or 30.5 or more and no specific basis can be assigned to it as long as the basic curve is corrected to co-inside with the x-axis. Thus the experience of the tester will play a very vital role in selecting the correct value based on the soil resistance offered to the travel of the waveform along the pile length.

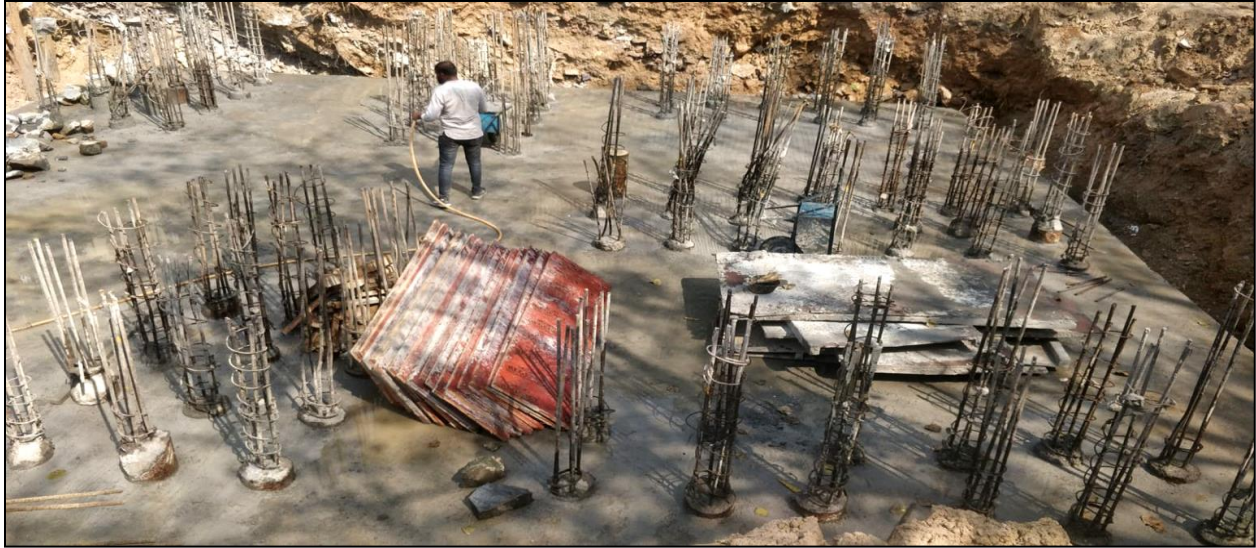
Figure 9 Picture of Closely Spaced Micro Piles

Figure 9 shows a picture of a project site with closely spaced bored micro piles and rebars projecting for significant height above cutoff level. It is a challenge to evaluate integrity for such small diameter piles where the diameter is small, percentage reinforcement is high, piles are closely spaced and rebar extending for longer depths above concrete. The first difficulty is to find space to place an accelerometer and top surface for hitting the pile with the hammer. Another problem is that the wave reflecting from the pile concrete gets super-imposed with reflections from rebars creating a ringing effect or a distorted wave. The software does provide filters commonly known as Wavelet or LO PASS to remove high frequency component or ringing effect of the rebar to make it appear smooth. LO PASS is generally not recommended in current practice. Also WL can be generally a value not more than 4m in most cases. Excessive use of WL may only distort data and not provide conclusive findings. Figure 10 shows data on such a micro bored pile. As evident, the waveform does not provide any conclusive findings on the pile integrity in spite of using WL as 3. The first author has evaluated several hundred data sets and most of them provided similar results. Thus testing of small diameter micro bored piles will in general not provide conclusive findings on pile integrity and instead high strain dynamic load tests on 5% of the piles should be considered to confirm integrity and pile capacity.

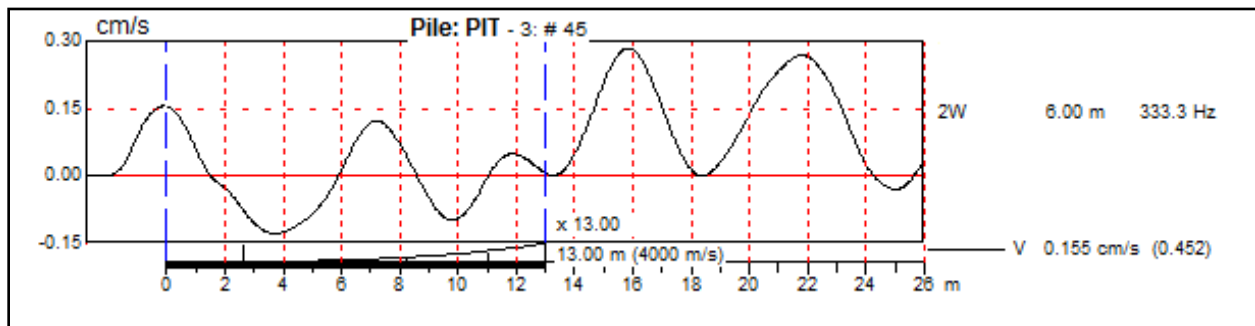
Figure 10 LSIT on Micro Piles

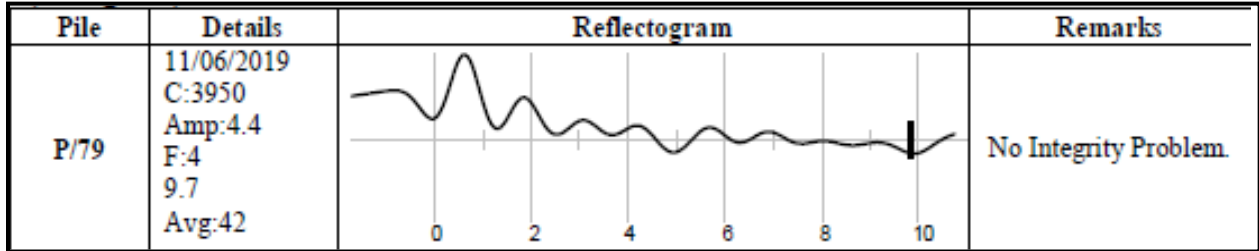
Figure 11 Incorrect LSIT Data and Interpretation

Another case study shows a graph in Figure 11 which is basically a sinusoidal curve with no apparent input peak and a clear output peak but was reported as having no integrity problems. The data shows that

amplification was only 4.4 for a length of 9.7m. The filter applied is not clear and apparently 42 blows seem to be averaged. The data was referred to the authors and since there was no clear graph, a re-test was recommended. The re-test done by the authors now clearly show a defect at 7m with proper data collection and processing as shown in Figure 12.

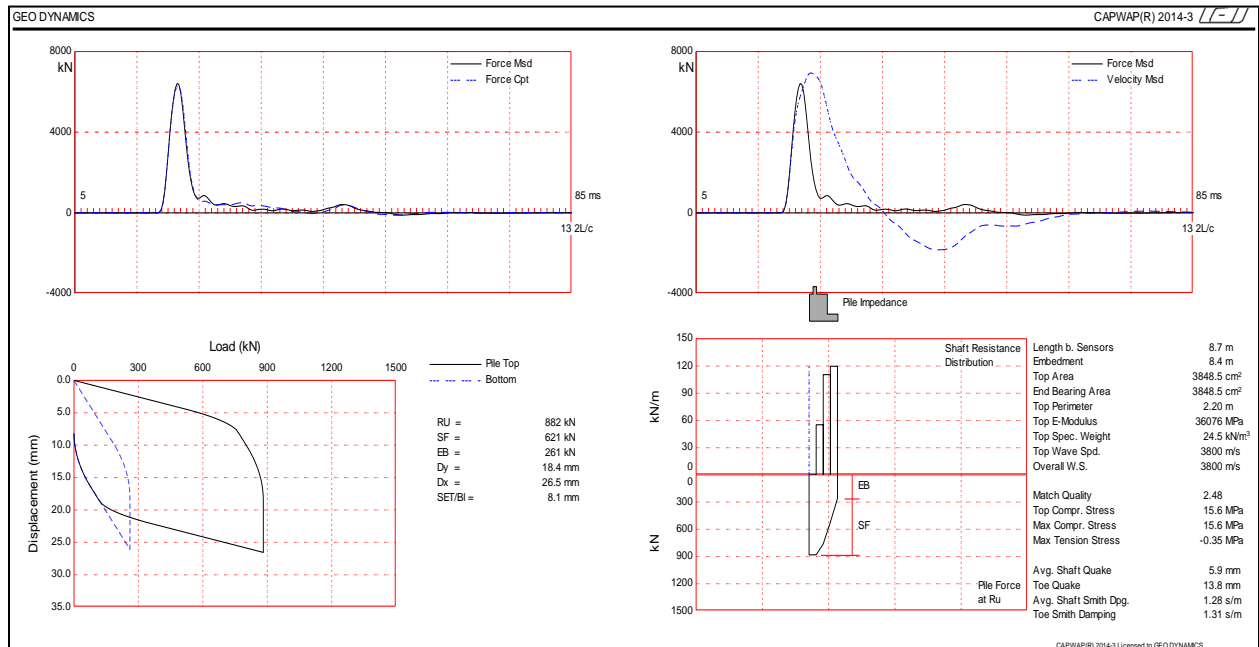
Figure 13 HSDPT confirms defect as seen in LSIT

To further verify the findings of low strain testing, a high strain dynamic testing was also conducted on the same pile. Figure 13 presents the results of such a test. As evident, the pile shows a significantly high a settlement of 26.5mm and a major impedance reduction at pile bottom to the extent of 73%. This shows the risks associated by employing testers who are not competent to conduct or interpret test data due to poor knowledge. The case study also highlights that mere acceptance of the pile in the test report has no relevance unless it is backed by proper data collection and processing.
