Condition Assessment of Existing Reinforced Concrete Foundation – Case study of HRSG Foundations at DUBAL

Abstract

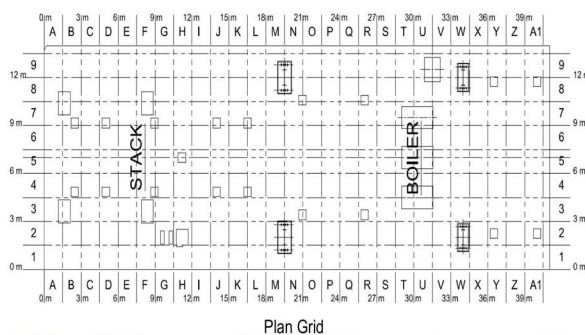
Each HRSG foundation is divided into the grid of approximate dimension of 1.5 X 1.5 m in order to locate each test at appropriate locations. The proposed grid marking are illustrated in the Fig. 1. Fig. 2 illustrates the UPV investigation going on the existing concrete foundation for one of the HRSG structure. Since the foundation footprint (14 x 40 m) is large, the response of UPV tests are imposed over the foundation layout grid (Fig. 1)

Fig. 1 Existing Foundation layout and illustrated grid marking.

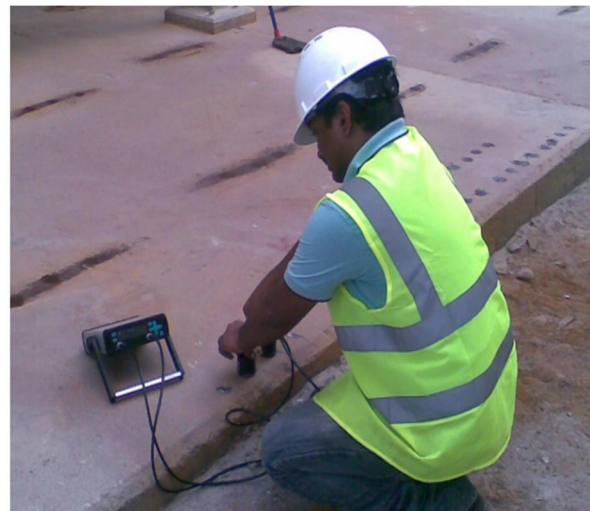
Fig. 2 Measurement of UPV tests on each specified grid.

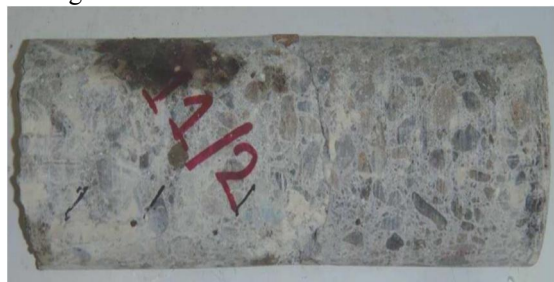
Since the extraction of concrete cores are considered to be destructive type of the tests, it was jointly decided to obtain limited number of the concrete. Since main intention of obtaining concrete cores is to investigate concrete compressive strength, 100 mm dia concrete cores are drilled from the foundation footprint. On each foundation, four (4 nos) representative concrete core samples were collected which were then send to laboratory for further investigations. Typical concrete core obtained from one of the foundation is presented in the Fig. 4.

Fig. 4 Extracted core from HRSG No. 11

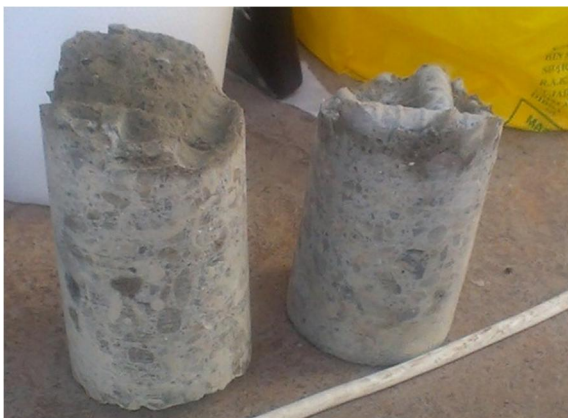
Though it was preferred to drill the core in the location where it can avoid the main reinforcement of the existing foundation, some places, drilled core encounter the reinforcement as well as illustrated in the Fig. 5. It accidentally provides many more information regarding the reinforcement existing within the foundation. The structural drawing available for these foundations (see Annexure A) suggested that the 16mm dia reinforcement bars were used as main reinforcements. The reinforcement pieces obtained from the concrete cores calibrated the reinforcement diameter placed within the foundation there by giving indirect indication of the correctness of the available structural drawing.

Fig. 5. Concrete core encountering main reinforcements. .

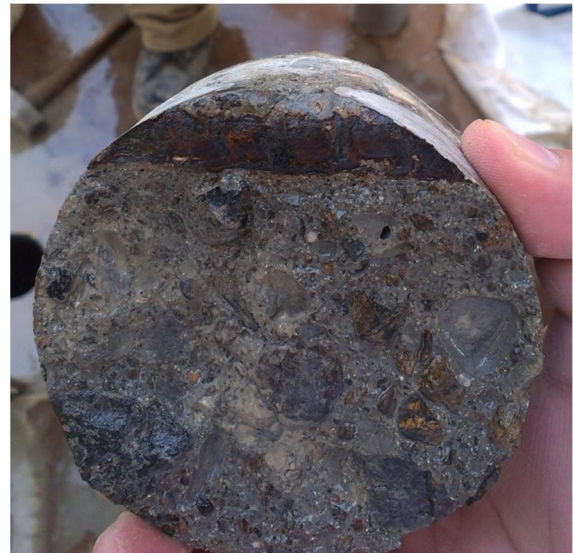
While extracting the concrete cores, it was observed that from the top surface approximately 60mm below, 8mm reinforcement was encountered as shown in the Fig. 6. The condition of the reinforcement was also not so good and it was felt that the top reinforcement may not be in adequate condition. However, such reinforcement were not

Fig. 6 Top 8mm reinforcement observed in the concrete core.

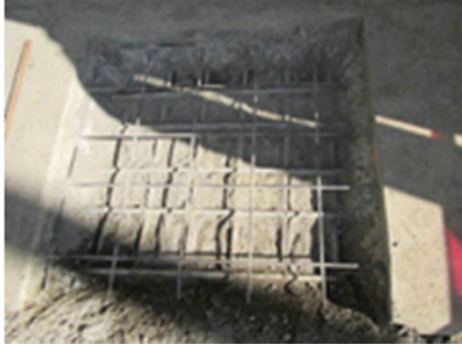
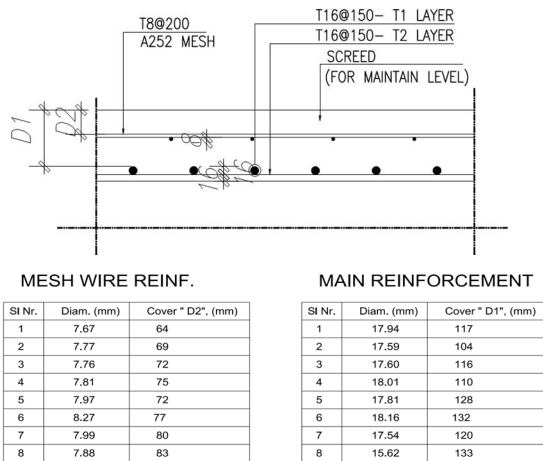
It was observed that a screen reinforcement mesh 8mm dia 200mm c/c bothways were provided as protection layer having top concrete cover as 60 mm. Main reinforcement mesh of 16mm dia bars at 100mm c/c bothways were provided under the screen reinforcement mesh having effective cover of 100mm or more. Such arrangement was available for all foundations which cleared the doubt regarding available main reinforcement. Some of the locations surface cracks were observed and extents of such cracks were visible in the concrete cores as well. It was observed that the extents of such cracks were limited to the top screen surface only and no

Fig. 7 Main reinforcement and top screen reinforcement observed at the top of the foundation with measured cover.

crack was observed to be penetrated up to main reinforcements in any of the existing foundations. Moreover, the widths of the cracks were not significant which lead splitting of the concrete cores refer Fig. 8. However, areas where cracks were visibly significant, it was decided to chip off the surface concrete and grout the areas.

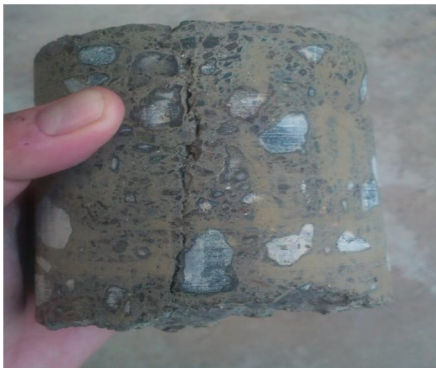
Fig. 8. Typical cracks observed in the top portion of the concrete core.

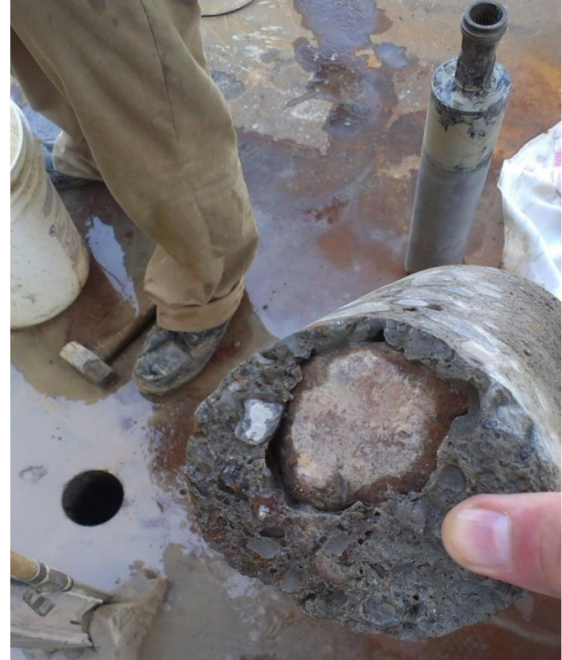
Obtained concrete cores also provided the opportunities to get some other insights (see Fig. 9) as well. Overall, extraction of these cores provided sufficient information to characterize the in situ concrete condition for many parameters related to condition assessment.

Fig. 9 Surprises in concrete cores
