SOME OBSERVATIONS AND EXPERIENCE WITH PILE INTEGRITY TESTING AT VARIOUS PROJECTS FOR ESSAR.

Keywords: pile integrity testing, pile foundation.

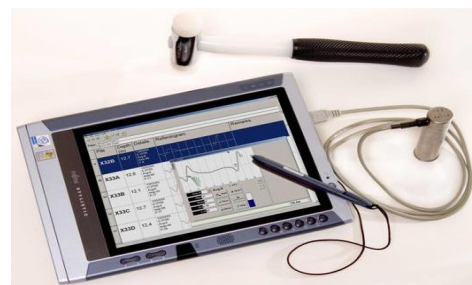
Fig. 1 PET Instrument for Hazira Site

QA/QC for pile foundation is carried out by performing Pile Load Tests along with Pile Integrity Testing. For Pile Integrity Testing, Essar Construction had purchased PET (Pile Echo Tester) from Piletest.com Ltd., UK for Hazira site and PIT-W (Pile Integrity Tester) from Pile Dynamics Inc., for Paradeep site. The Integrity testing has been carried out on larger number of piles in order to maintain highest standard of quality along with faster construction progress. The instruments used are shown in Fig 1 and 2.

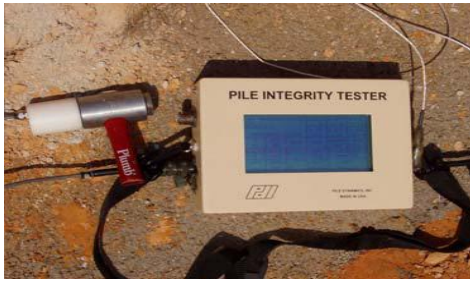
Fig. 2 PIT Instrument for Paradeep Site

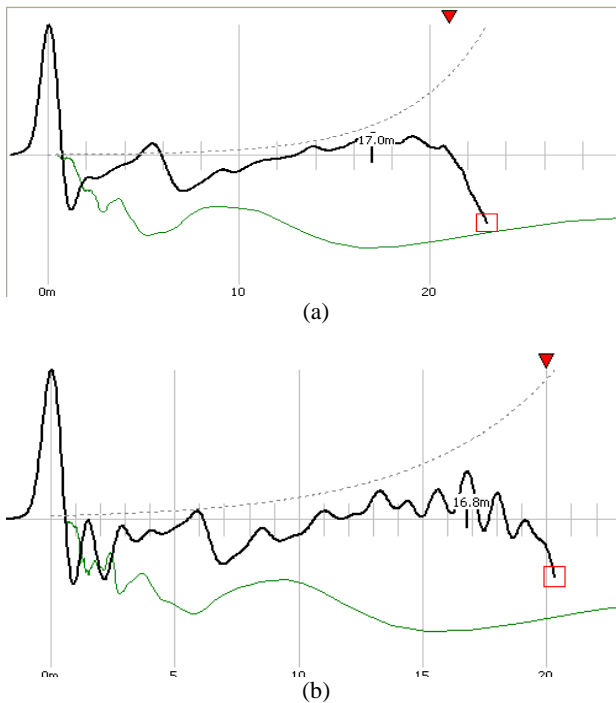
Fig. 3 PET records for Pile at Hazira.

The observations of pile integrity testing were recorded regularly. It has been found that in some of areas of the site, the collected reflectograms shows defects at various locations. Few representative recordings are presented in Figure 3a and 3b.

It was observed that in the particular area especially near water tank, the number of piles have the reflectogram like Figure 3. It was also seen from the record that piles show tendency to have necking at a depth varying from 3 to 7 m below ground level. It was than decided to test almost all piles in that area for its integrity. In some area piles have been exposed by excavation to check pile shape physically (Figure 4). It was observed that PET record has correctly expressed the pile shapes. Various piles have been found in bad shapes showing necking and other defects, which later build up as the defects are at relatively shallow depth.

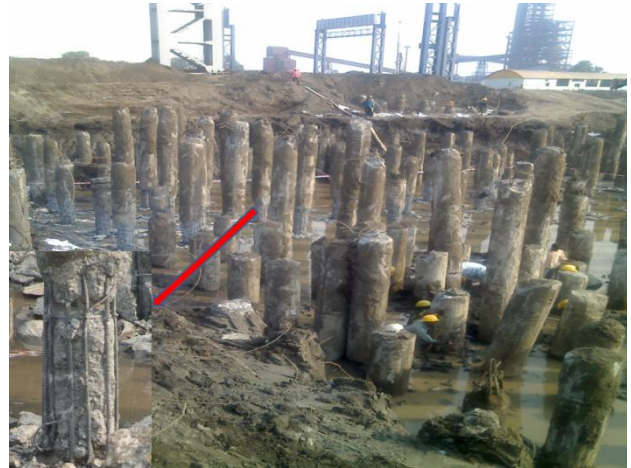
Fig. 4 Excavated area for checking pile profile

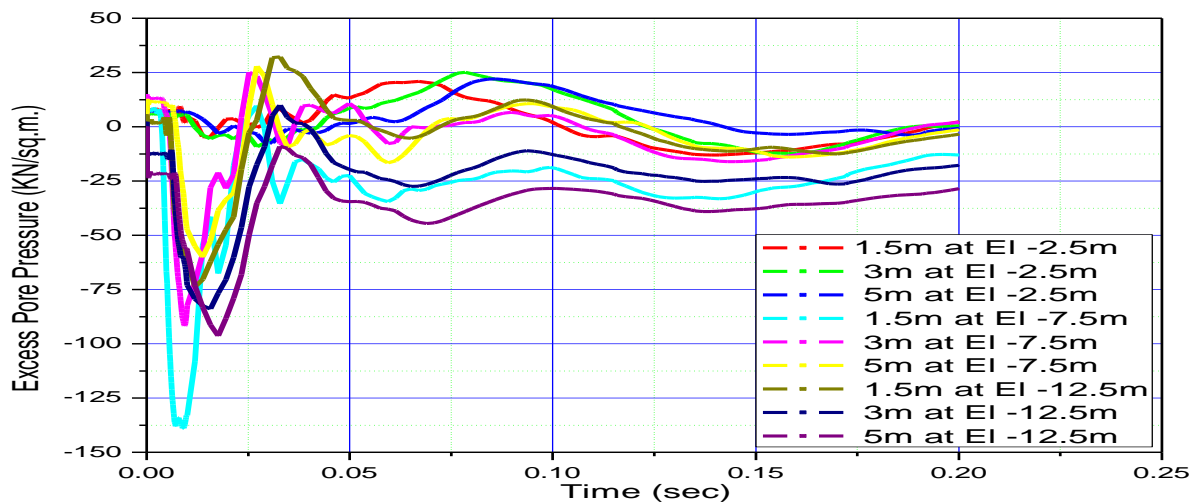
Fig. 6 Excess pore pressure generated due to Pile driving

From the study it was found that the generation of the excess pore water pressure cause problems for the freshly placed piles in the vicinity (Figure 5). As the driven piles installed are of displacement piles, the radial pressures exerted due to soil displacement along with the excess pore pressure generated as the water table is at 2m from GL. This has caused serious defects on the freshly placed concrete piles. The excess pore pressure was estimated from the finite element model and found in the range of 137 KN/m² (Figure 6). This range of pore pressure has resulted in serious defects of necking at various locations in the freshly installed concrete piles (i.e. 2 to 6m from GL).

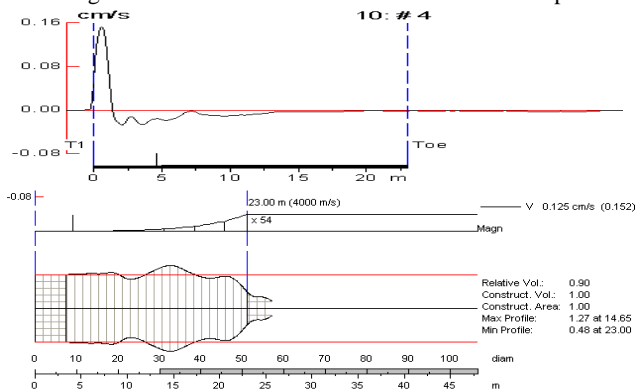
Fig. 10 PITW with profile for pile at Paradeep

Unnecessary magnification of the record may give misleading information and judgement requires great experience for correct interpretations. Later Essar Construction has purchased PIT-W for pile integrity testing at Paradeep. Testing had been carried out on the various locations and most of the piles found in good shape. PIT-W instrument with profile plotter have added great confidence in use of pile integrity testing at site (Figure 10). The profile can be approximated using inbuilt software and one can use some advanced features for the correct interpretation of the record.
