# CONSTRUCTION OF UNDERGROUND SCALE PIT AT ESSAR STEEL – HAZIRA :- DEWATERING AND CONSEQUENCES

**ABSTRACT:** Essar Steel Hazira Ltd has proposed new integrated steel plant near Hazira under SEZ developments. During the construction of 25m deep underground scale pit, there are various geotechnical problems occurred due to dewatering operations. Dewatering followed by soil movements cause settlements of nearby structures including piled raft, chimney etc. This paper describes the entire study from origination to the solution of the settlement problems. Due to these consequences commissioning of entire area had been stopped as settlements have been observed on almost all the adjacent structures. Settlement was continuously monitored on important piled raft and some adjacent structures during entire operation. Paper also describes the methodology adopted for arresting the settlements and some design changes has been made for bottom plug for scale pit.

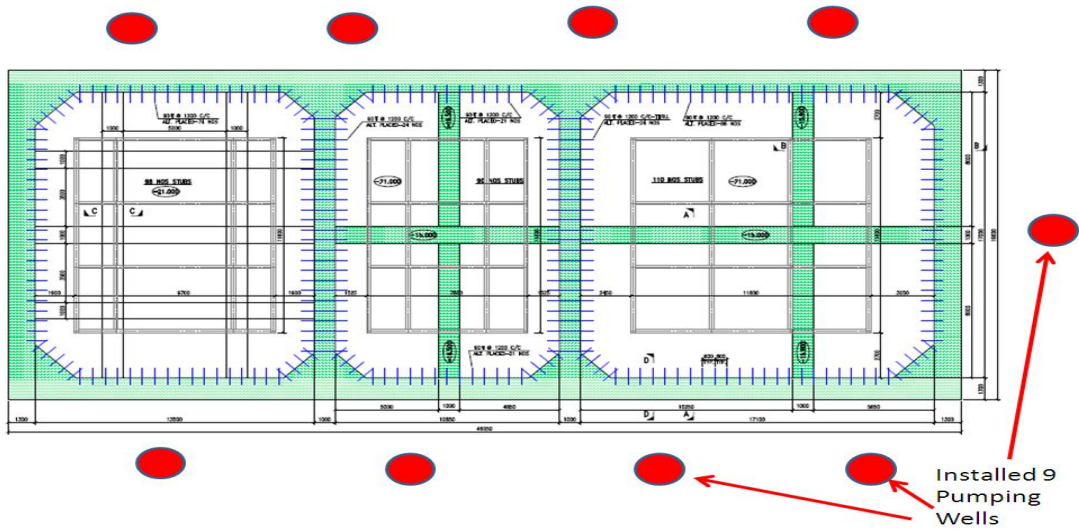
Figure 1 Scale pit for Hazira Plate Mill

As the direct dewatering from the pit itself has induced considerable settlements to adjacent structures, it is required to dewater in very controlled manner. For the purpose of lowering the ground water table in scale pit area, 30 to 35m deep wells were provided at locations shown in Figure 1. The peak discharge of all the pump together is about 150 m<sup>3</sup>/hour.

Substituting values the total discharge required for a drawdown upto  $-20\text{m}$  and calculating further, it was decided to install 9 bore wells of 20BHP around the Scale Pit area (4 well on each 46.05 m face and one on right hand side of 19.6m face refer Figure 1). Even after that the water level outside the scale pit could not be lowered  $-18\text{m}$  below Ground level. During the construction of the bottom raft the vacuumed dewatering pump has been employed along with the three other pumps in order to compensate two failed deep wells.

As mentioned above out of total 9 installed deep wells, 1 has been blocked due to the seepage of fines and misalignment and another was working but not running at full capacity due to blockage. Even though the pumping capacity for lowering the water table is found to be adequate initially the disposal of these huge quantities of water was also a big problem. As the Plate

The raft bottom slab was redesigned and constructed as per new situations. 3m thick raft was constructed in the Scale Pit in three stage as per the Figure 1. The total 1800 m<sup>3</sup> of M-30 concrete was carried out without interruption with installed batching plant. It was very difficult to place reinforcement and bind at -22m hence the reinforcement template was built on ground and lowered using cranes (Figure 5).
